Western Bay of Plenty District Council

**Bramley Drive Landslip Hazard
Assessment**

Tonkin & Taylor Ltd

June 2011

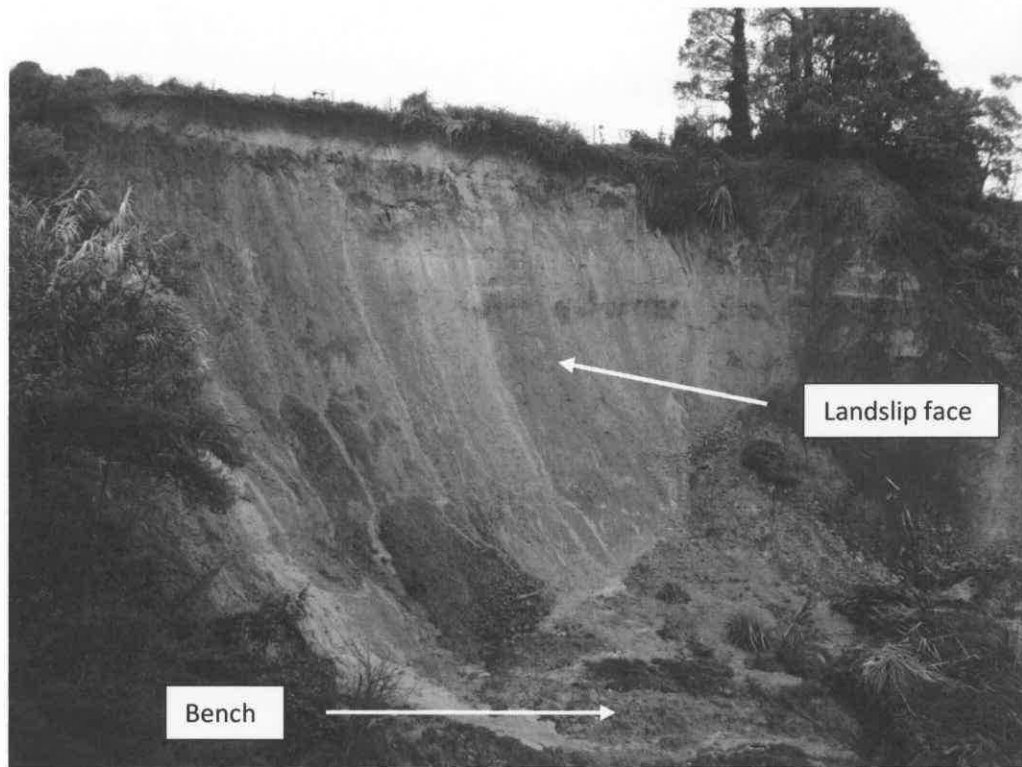
The recent landslide activity occurred over a 60 m width and is fully contained within the 1979 landslide. The main regression has occurred at the southern end of the headscarp. The main slip surface appears to coincide with the sensitive ash layer located on a bench in the slope approximately 20 m below the crest of the headscarp. The failure has resulted in an oversteep headscarp and considerable inundation at the base of the slope.

In comparison to the landslide profile before the events of 11th May 2011, the main scarp is much steeper, and the bench is more pronounced. The landslide has not increased in width or in length although the headscarp has regressed by up to 6 m. The debris has re-inundated approximately the same area that was affected in 1979. At its southern end, the landslide has undermined the barrier fence (see Figure 3).

Photograph 1- Photograph of landslide main scarp and pronounced bench.

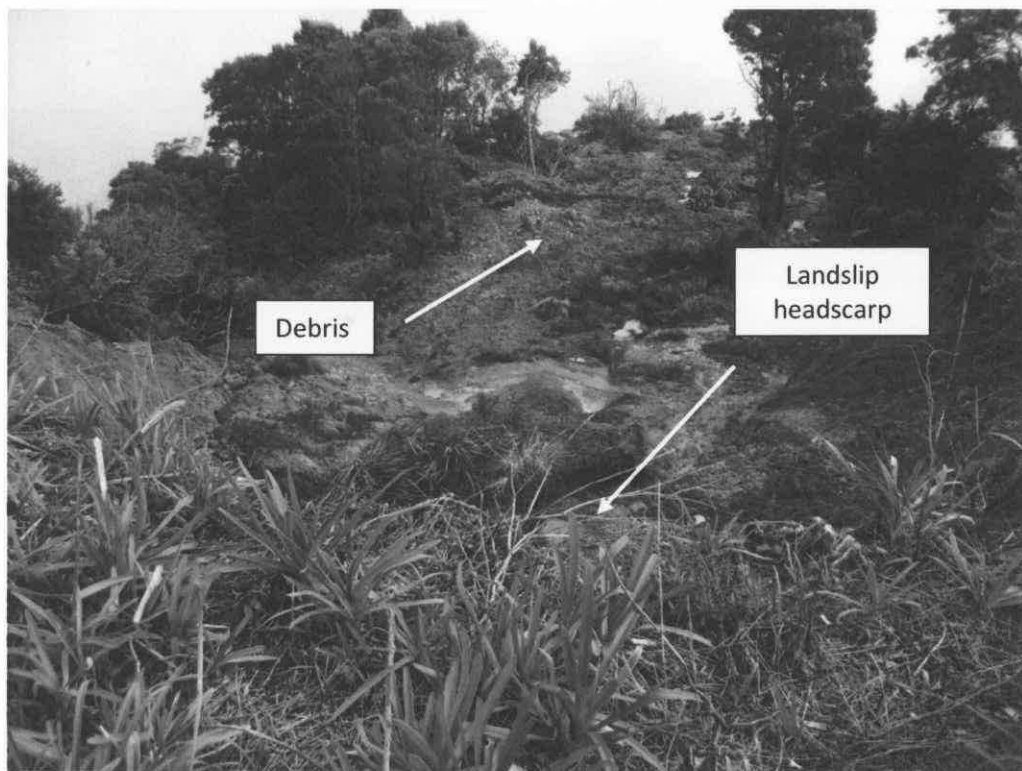
Of particular note is the highly sensitive silt unit which is a large contributor to slope instability right along the western margin of Omokoroa Peninsula. This material has a very high porosity but low permeability. It inhibits the downward percolation of water and causes a perched water table. The material is weak in compression with a high natural moisture content that often exceeds its liquid limit. The silt exhibits very low values of cohesion but relatively high angles of internal friction. It is able to support relatively steep slopes until saturated. Upon saturation the pore pressure forces the grains to separate and the structure of the material to collapse. Once disturbed the material loses all integral strength and becomes highly fluid and mobile. This contributes to the extensive run out distance of the displaced material².

Photograph 2- Showing the extent of the failure deposit.

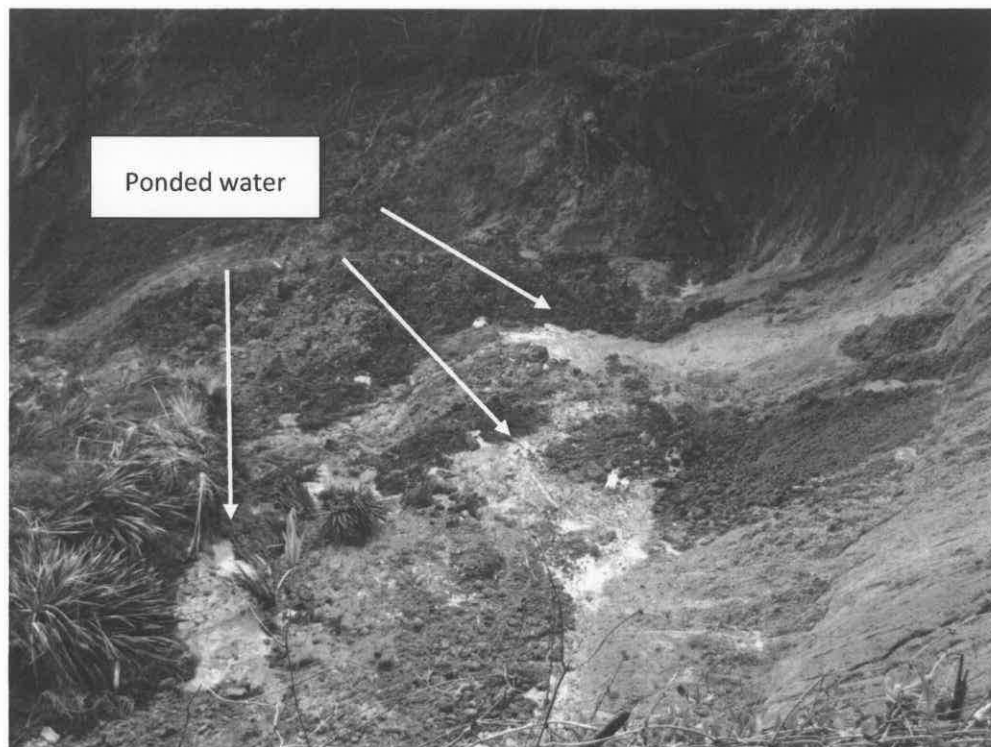
During visual inspection it was noted that overland flow was still evident from near the headscarp of the landslip. Seepage was also occurring over much of the headscarp, but particularly from a point midway up the headscarp. This indicates the existence of a perched water table with groundwater flowing above a relatively impermeable unit. This groundwater flow is now channelled due to the effects of paleotopography.

Photograph 3- Ponded water situated on the bench below the main scarp.

Installation of drainage will be required whichever option is chosen. This would involve the drilling of two rows of horizontal drains into the main scarp on the upper and lower surfaces of the sensitive silt. This solution would lessen pore pressures in the sensitive silt and reduce the regression rate of the headscarp. It would not prevent future landslide activity but would likely decrease the frequency and magnitude of events. The drains would be installed at approximately 5m centres horizontally within the main scarp. Water from these drains would need to be collected by a non-perforated pipe before ultimately discharging to the base of the slope. The drains would need to be maintained and checked periodically to ensure that they remain free of blockages.

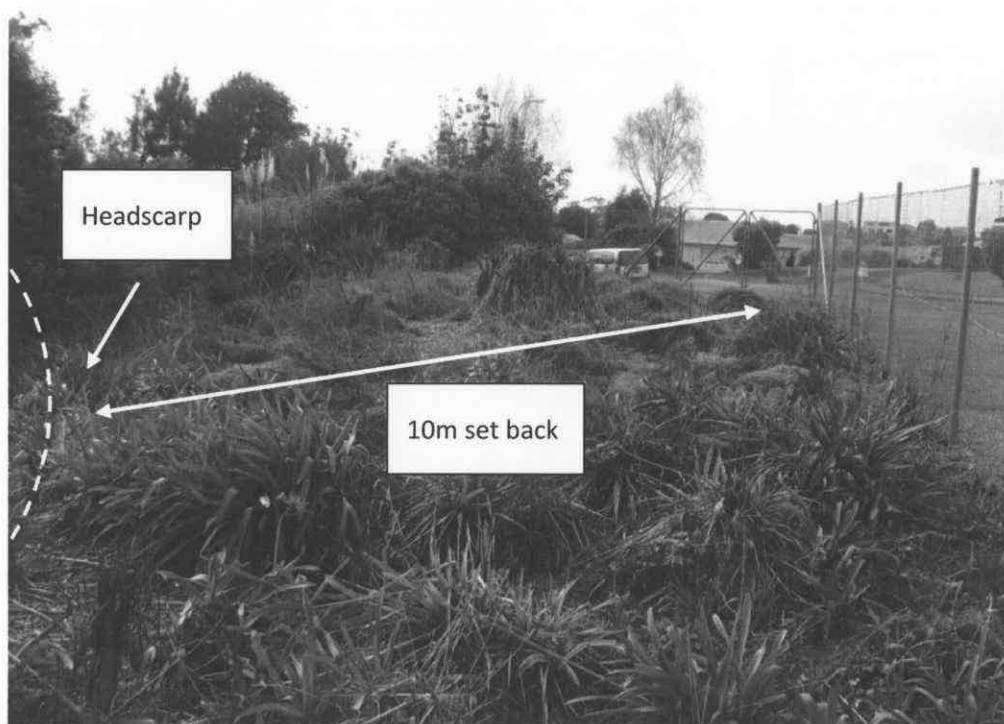
The portion of the fence behind the centre of the headscarp is expected to remain in its current position in the short term. In the medium term it is at risk of collapse due to undermining. A Council water supply main is situated in the grass verge between the footpath and the road and may also be at risk of damage resulting from regression of the headscarp in the medium term. The portion of the headscarp at the southern end has undermined part of the fence around the landslide. Further portions of the fence are likely to be undermined in the short term.

Photograph 4- Showing the 10m set back from the centre of the headscarp to the fence.

If left to recede back to a sustainable slope angle the landslide would require further barriers to restrict access by the public. This would involve extension of the existing fence to join the boundary fence on No. 5 Bramley Drive. The fence line would also need to be set back from the headscarp to a point close to the footpath and adjusted according to future landslide activity. Regression of the landslide would need to be monitored, initially on a weekly basis and on a monthly basis for the next six months (until the end of winter). Regular visits should be maintained following this period.
